**California Department of Public Health
Occupational Health Branch**

**FATALITY ASSESSMENT AND CONTROL EVALUATION
PROGRAM (CA/FACE)**

**Lake Maintenance Worker Drowns while Removing
Weeds from a Golf Course Lake
Case Report: 15CA001**

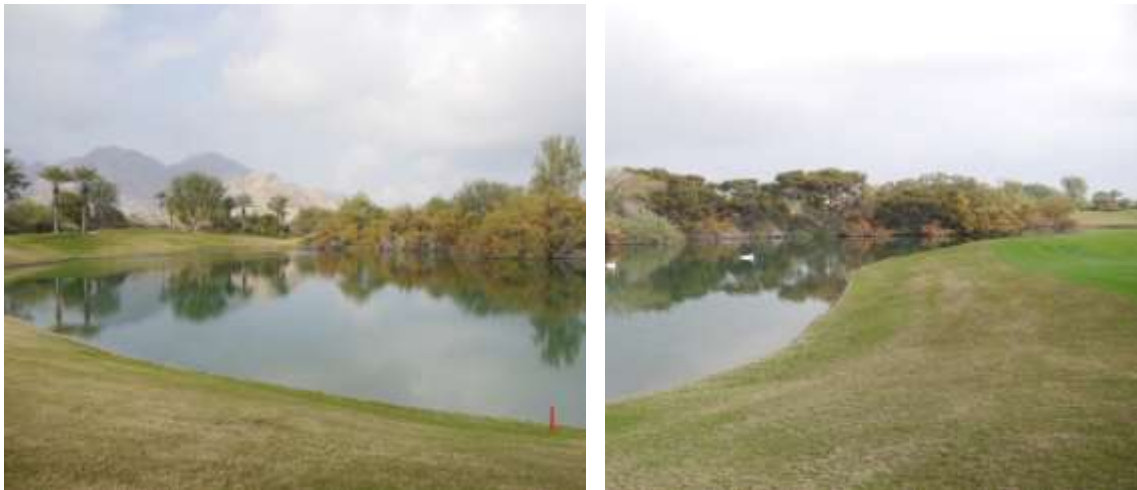
The incident scene was a 4.5-acre golf course lake (Exhibits 1 & 2). The lake served as an irrigation basin, receiving run-off water from an adjacent canal. Water from this lake flowed out through a pipe to another water feature on the course. Overgrowth of lake weeds and algae peak during the summer months. The lake was reportedly thick with weeds at the time of the incident.

Exhibits 1 & 2: View of lake where the fatality occurred (landscape view not to scale; photo taken when lake was free of vegetation).

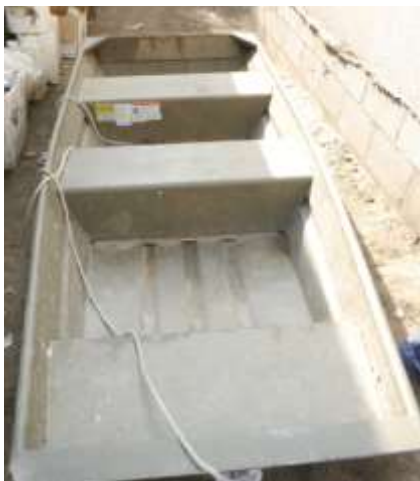
Exhibit 3. Boat used by victim

The victim was not wearing a PFD and there was no rescue equipment in the boat or onshore. Witnesses reported that the square-nosed boat that was being used that day may have contributed to the instability of the craft, leading up to the boat capsizing and the victim falling into the water. The boat involved in the incident was being used temporarily while their other boat was being repaired. The square-nose and shallow-hull design allows weeds to build up in front of the boat, impeding movement and requiring the boat operator to clear the weeds from the front of the boat, often from a standing position. Shifting one's weight in such a manner changes the center of gravity, decreasing stability. It was reported that the victim may have been clearing weeds from the boat's path when it overturned. There is inconsistent information as to whether the victim knew how to swim. During the CA/FACE interviews, the employer and

Discussion: The victim was alone in the boat and maneuvering in a standing position with a poled net to surround the weeds. In so doing, the boat probably became unstable and capsized. Whenever possible, work should be done from a sitting position. Having two persons in the boat when corralling weeds will help distribute the load more evenly, reducing the potential for capsizing. In addition, having a “buddy system” on the boat adds another level of safety in the event someone falls into the water, as a life ring can quickly be thrown to the person overboard.

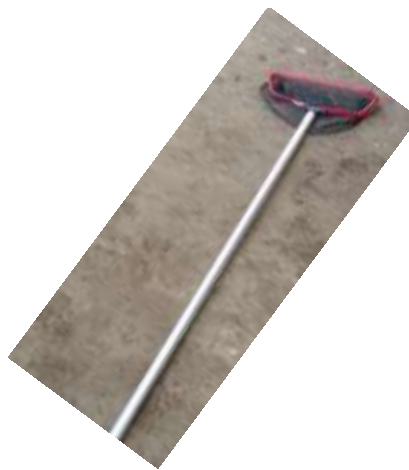
Exhibit 4. Poled net used for paddling the boat

Discussion: The victim was using a long pole with a net (skimmer) as a means for propelling the boat through the water. This pole and/or the rope used to corral the weeds may have become caught on weeds, or contributed to the instability of the boat, causing it to capsize. Employers should provide proper equipment for navigating non-motorized watercraft. Using proper equipment, such as strong and adequately sized paddles or oars, helps with controlling and navigating small watercraft safely.

Recommendation #5: Provide proper equipment for navigating small non-motorized watercraft.

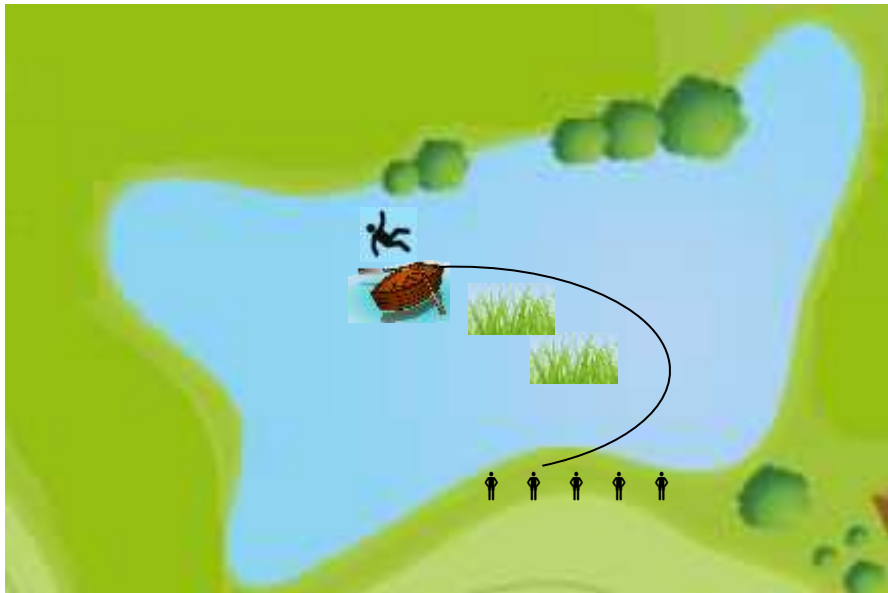
On the day of the incident, the victim was working from a small boat while “corralling” weeds from a golf course lake maintained by the victim’s employer. Corralling is an in-lake management method used for gathering floating weeds and moving them to the shoreline for disposal (Exhibit 5). During this procedure, a rope is attached to the boat and secured to the shore; the person in the boat takes the line out and surrounds the weeds in a large circular pattern and returns to shore. According to coworkers, the rope is allowed to sink to the bottom, at which time the workers onshore pull the rope, extracting (culling) the underwater weeds, and bringing them closer to the shoreline where they can then be raked onto the shore for disposal.

On the day of the incident, the victim started work at 5:30 am. Throughout the day, the victim had made multiple passes in the boat, corralling in the weeds. At roughly 1:45 pm, the victim set out alone in the row boat to make one last pass at corralling the lake weeds before ending the work day. Five co-workers, who were all relatives of the victim, remained onshore to help with the removal and disposal of the weeds. The victim was paddling the boat from a standing position, using the poled net that is pictured above (Exhibit 4). He was about 90 feet offshore when the boat overturned, causing him to fall into the water. The onshore workers saw the

Exhibit 5. Graphic depiction of corraling activity leading up to the fatal incident (not to scale).
